## SELECTED CASES OF PAINT COATING EXAMINATION

Janina ZIĘBA-PALUS, Beata M. TRZCIŃSKA  
*Institute of Forensic Research, Cracow, Poland*

**ABSTRACT:** Criminalistic examination of paint fragments is often useful in determination of a run of an event. Three real cases will be discussed. Two of them concern the hit-and-run accidents and the third one refers to identification of lacquer used for parquet painting in connection with poisoning caused by volatile paint components. In all cases comparative analysis was conducted.

*Problems of Forensic Sciences, vol. XLVII, 2001, 147–153*  
*Received 25 October 2000; accepted 15 September 2001*

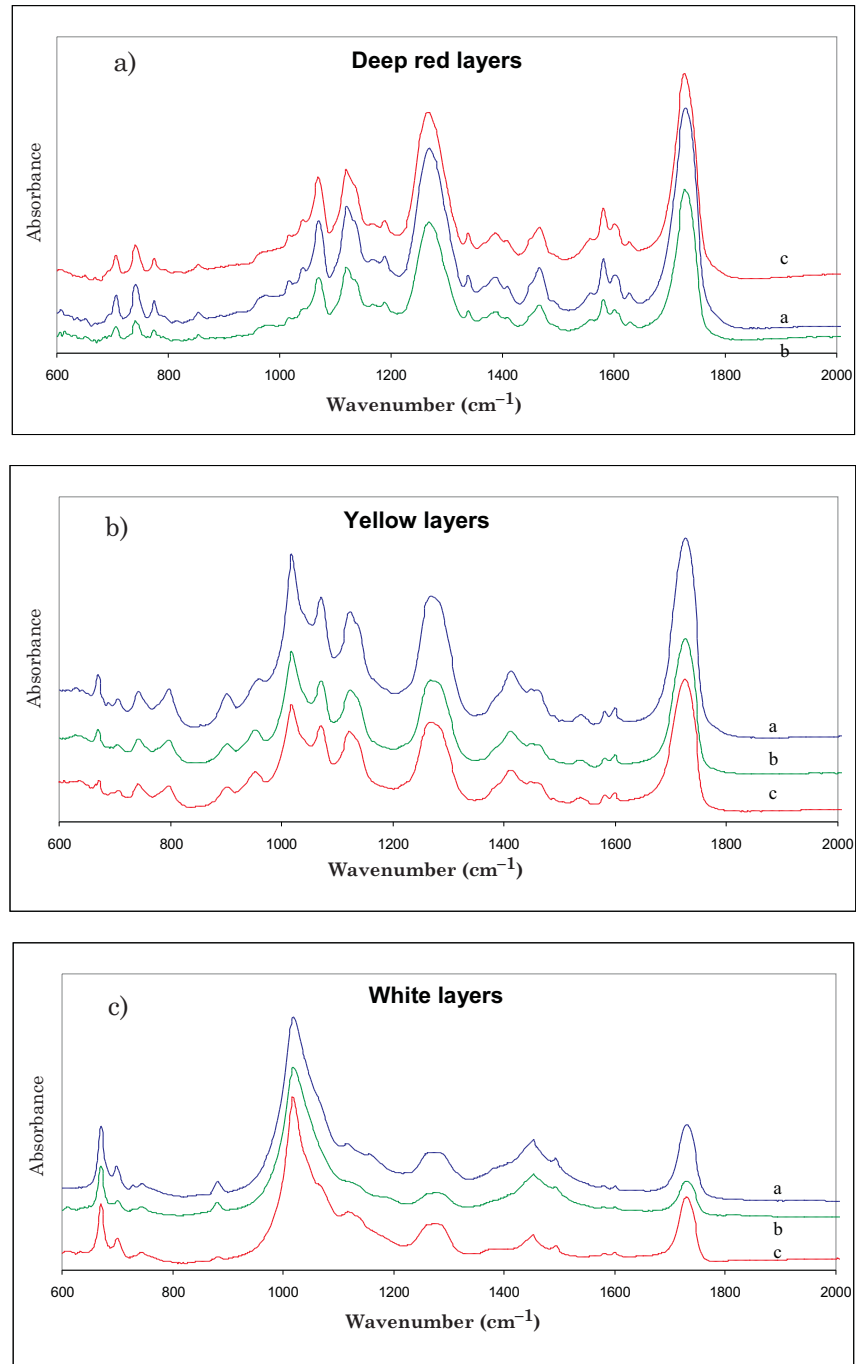
As a result of the laboratory examinations it was found that all samples consisted of multi-layer car paints: the outer layer – deep-red, then the yellow one, deep-red one, white one and the red one. The thickness of the corresponding layers in the examined bits revealed approximate conformity (Table I). So did the chemical composition of the three consecutive layers (Figure 1).

Fig. 1. Infrared spectra of corresponding layers (deep red, yellow, white) in paint chips coming from: parking place (a), road (b) and clothing (c).

The top layer consisted of the modified alkyd paint, containing compounds of iron and lead chromate. The chemical composition of the remaining layers was the following:

- yellow layer – alkyd resin, talc, ferrite yellow, titanium dioxide, zinc compounds;
- deep-red layer – modified alkyd resin, lead chromate, iron compounds;
- white layer – ground coat paint, carbonates, talc;
- red layer – alkyd-nitro-cellulose paint.

So, the compared paint samples reveal similar layer structure and thickness of the corresponding layers as well as the chemical composition of 3 consecutive layers. In addition, plastic elements found on the crime scene were recognised as being typical for the same car model as that of the suspect.

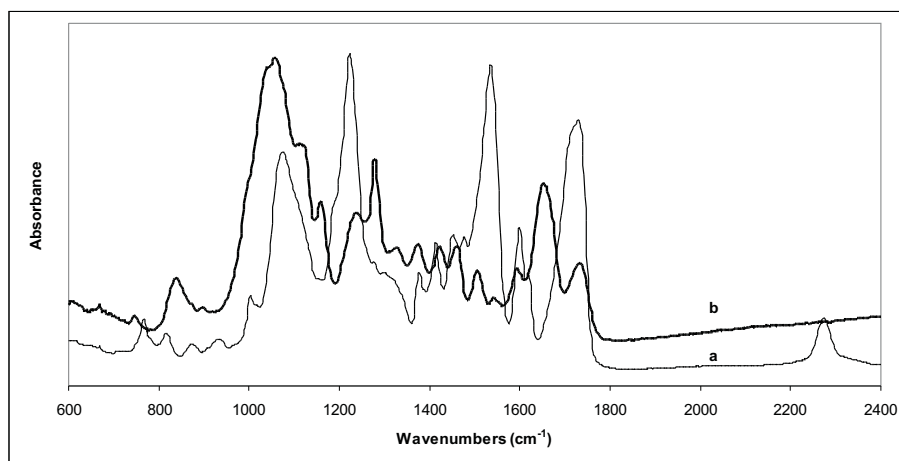
It was found that the parquet floor bit was varnished with a colourless lacquer. Two types of lacquers: polyurethane and nitro-cellulose were found on the floor bit (Figure 2). At the distance of 1.5 cm from its edge there is a clearly discernible borderline between superimposed lacquer layers (fragments of the surface painted once or twice). Some fragments are varnished by the use of both lacks, some only by nitro-cellulose lacquer. Infrared spectrum of the lacquer of the outer layer in the double-layer coating conforms to the spectrum of polyurethane lacquer "Harzłak" which, together with polyurethane resin and diisocyanamides contains aromatic hydrocarbons, toluene and xylol.

IR spectrum of lacquer found on the wood in single-layer coating conforms to the spectrum of the nitro-cellulose lacquer (Kapon), containing methyl ketone, ethyl acetate, butyl acetate, amyl acetate, isobutyle ketone, anaesthesia ether, ethylene glycol, cyclohexanone, and as diluents, alcohols and aromatic hydrocarbons. Nitro-cellulose lacquer was placed directly on wood.

Fig. 2. Infrared spectra of polyurethane (a) and nitro-cellulose (b) lacquers.

Conclusions: it was stated that both types of lacquer nitro-cellulose and polyurethane, which are non-toxic after drying up, are produced on the basis

of organic solvents. It was not possible to establish whether the nitro-cellulose lacquer remained after the preceding painting, or, was the ground coat layer under the top lacquer (polyurethane).
