PAINT AS EVIDENCE – SELECTED CASES

Janina ZIĘBA-PALUS, Beata M. TRZCIŃSKA

Institute of Forensic Research, Cracow, Poland

Problems of Forensic Sciences, vol. LVII, 2004, 124–138

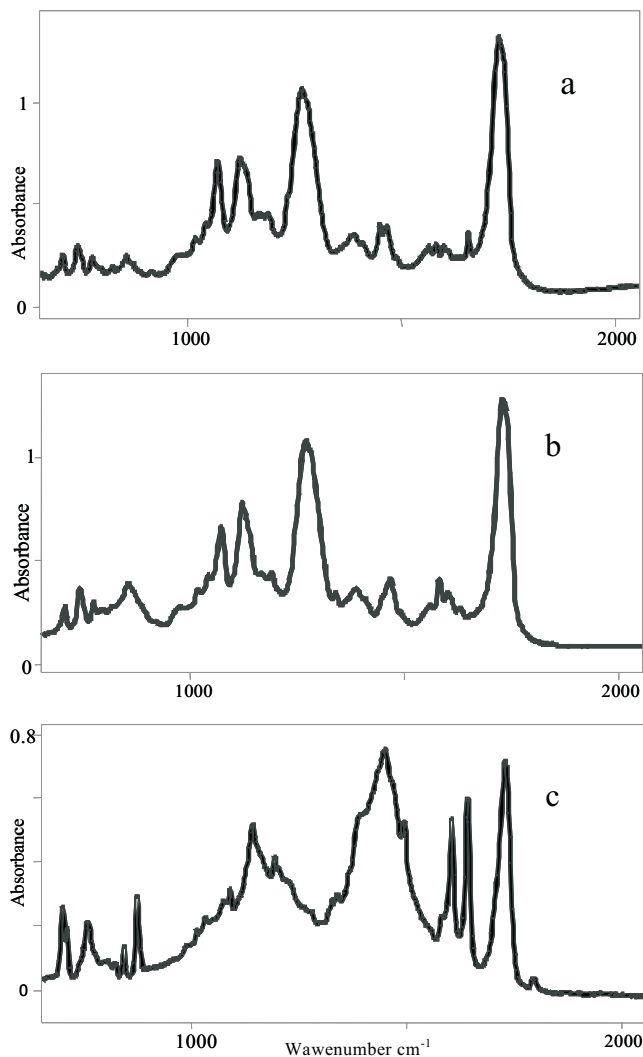
During optical examinations of the submitted clothing, several additional green paint fragments were found on its surface – a cross section revealed many layers visible, hence originating from a repainted, repaired paint coat. However, the presence of other traces that usually accompany these types of events, such as mechanical damage to clothing, glass fragments or plastic materials was not ascertained. The majority of the paint chips revealed on the clothing had a different morphological build to that of fragments found at the scene of the event. Only two microfragments had the same morphology, i.e. the same number of layers, arrangement, colour, thickness and chemical composition as fragments found on the road (Figure 1).

Analysing results of the performed examinations, one may assume that the victim was hit by a green vehicle whilst he was on the road. The concordance between the colour, morphology and chemical composition of car paint fragments present on the clothing and those found on the road supported this conclusion. The vehicle which was involved in the incident could have been the car of the suspect: this was supported by the concordance of the colour and chemical composition of the external green layer of the examined samples of paint originating from the clothing, the road and the fragment of the car body. The conclusion about the participation of the suspected vehicle in the event was, however, weakened by the fact that the concordance related to only one layer – the external one. So, taking into account the prevalence of green cars, in the expert's report it was stated that one cannot exclude that the victim could have been hit by the vehicle of the suspect.

Fig. 1. Infrared spectrum of top layer in paint chips taken from the clothing of a victim (a, b, c); spectrum b) is similar to the spectrum obtained for the top layer in a chip found on the road.

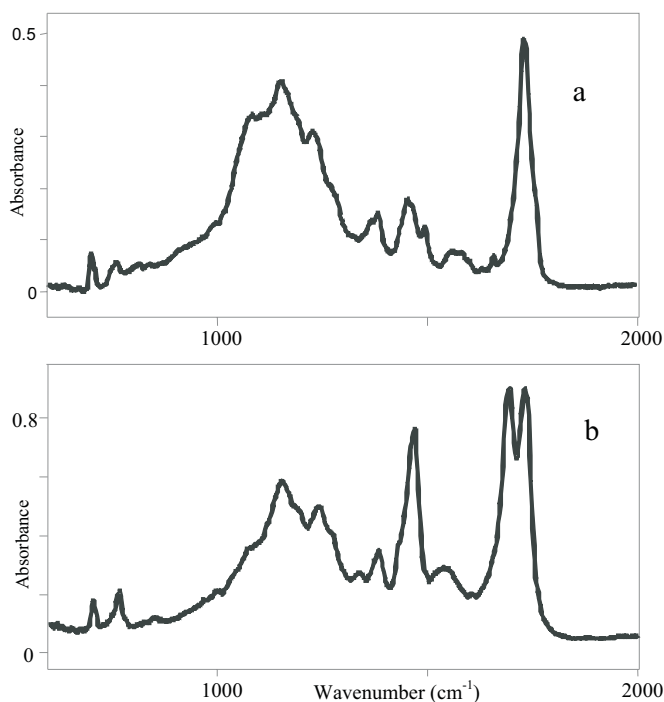
On the basis of results of the examinations, it was established that the examined chips do not come from brand new coats, but, on the contrary, from coats that had been subjected to repairs and repainting, and that the original factory colour of the coat was red. Thus, it was concluded that the questioned car, originally red, was re-painted a blue-grey colour and its identification number was changed, adapting it to match documents already possessed by the owner relating to the previously possessed vehicle of the same make.

Fig. 2. Infrared spectra of blue layers visible in examined paint chips taken from the vehicle.

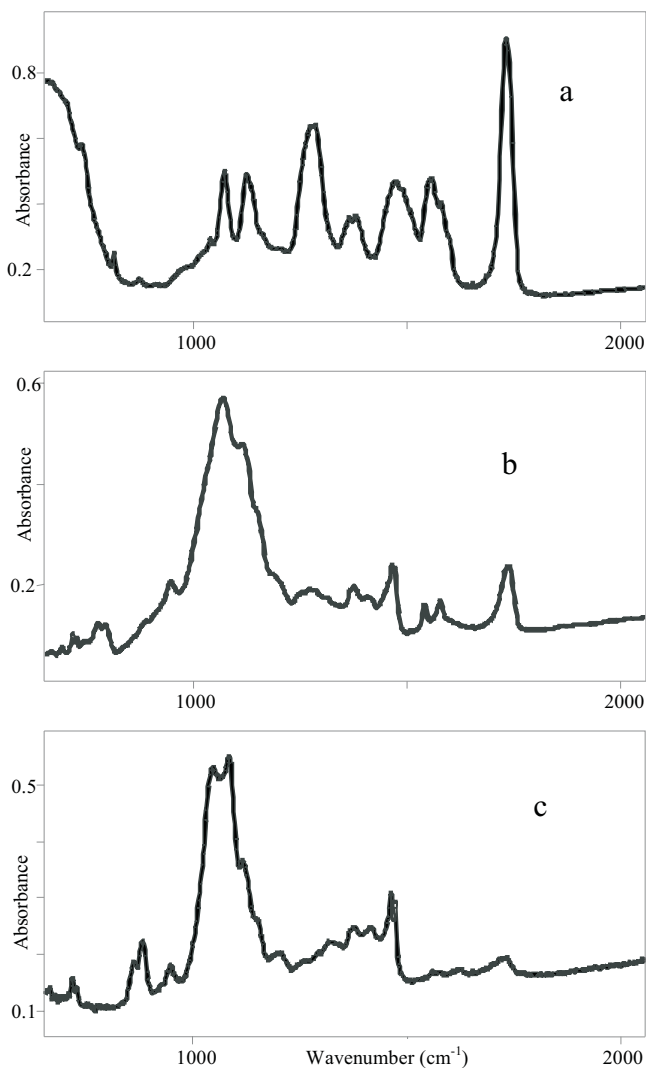
Fig. 3. Infrared spectrum of: a) unchanged Tico paint coat; b) damaged Tico paint coat; c) Scansol – dried.

As result of IR spectrometric analysis it was ascertained that the white layer originating from the undamaged fragments of paint coat and from the comparative material is a paint with a binder composed of alkyd resins – ortho-phthalic and melamine, containing titanec white as the basic pigment. The colourless membrane visible on the damaged fragments of the paint coat of the Tico had a composition consistent with that of a preparation by the trade name Scansol, which is a paint stripper (Figure 3). The paint coat of the Polonez contained an external colourless layer with an acrylic-mela-

On the basis of the results of the performed examinations, it was ascertained that most likely the paint coats on the bodies of both cars were damaged as a consequence of pouring Scansol on them. This preparation contains dichloromethane embedded in a cellulose carrier, which acts on the polymer coat by gradually causing its degradation. The differences observed in the appearance of the damaged fragments of paint coats of both vehicles, and thus in the IR spectra obtained for them, could have resulted from different chemical compositions of the paints, which consequently resulted in their different reaction to the same stripping agent.

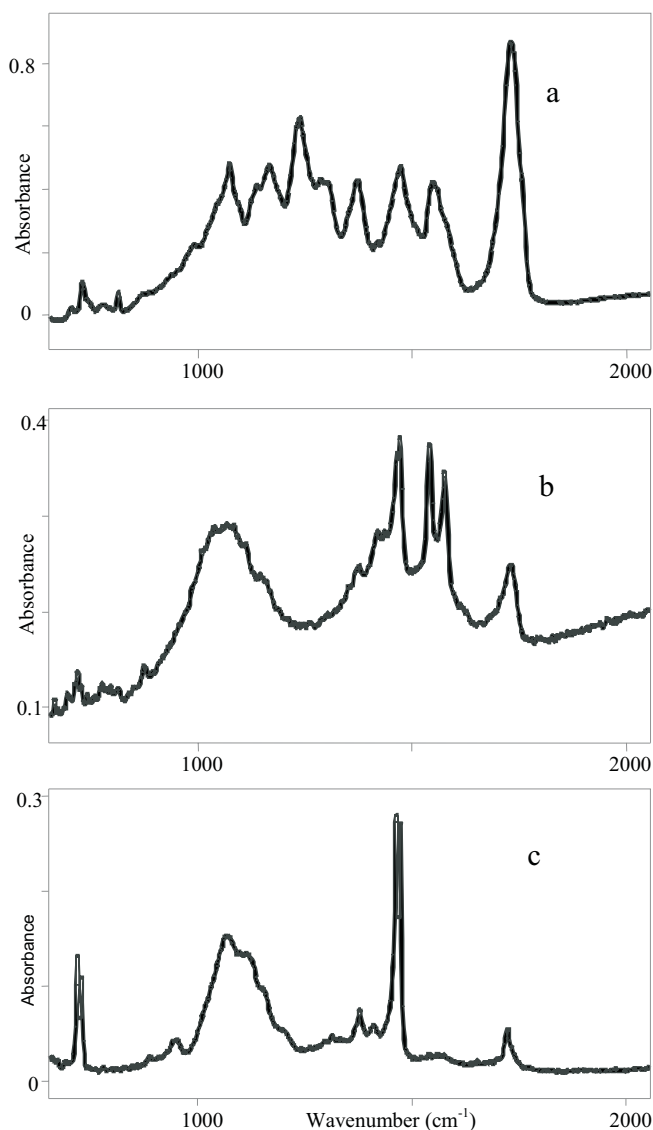
Fig. 4. Infrared spectrum of: a) unchanged Polonez paint coat; b) damaged Polonez paint coat; c) Scansol.

mine binder and beneath it a green layer with a metallic lustre, containing a binder composed of alkyd (iso-phthalic) and melamine resins and flakes of aluminium and grains of a green organic pigment. It was the colourless layer of the coating that was, above all, damaged. Its surface was wrinkled and loosened. In the IR spectrum of this layer, beside the absorption bands of the binder, bands that also appear in the spectrum of Scansol were visible (Figure 4).
