PASSENGER CAR – SEMITRAILER UNDERRIDE CRASH AT NIGHT – A CASE REPORT

Wojciech WACH, Jan UNARSKI

Institute of Forensic Research, Kraków, Poland

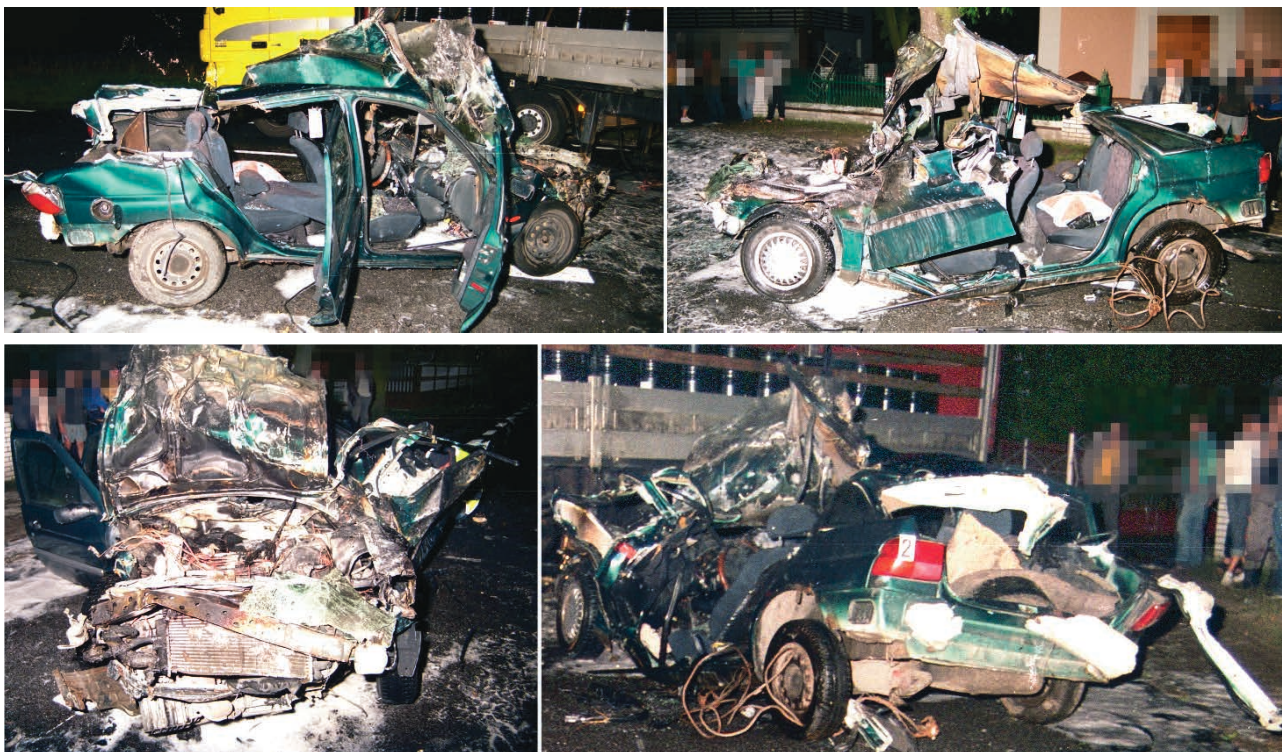
In the photographs the Ford looks as if it had suffered from catastrophic damage, but, in actual fact, the primary damages should be separated from the secondary ones. The primary ones are located in the front and are a direct effect of the collision, while the secondary ones are an effect of the rescue operation and the fire, and they include:

Fig. 2. Damage to the Ford Escort.

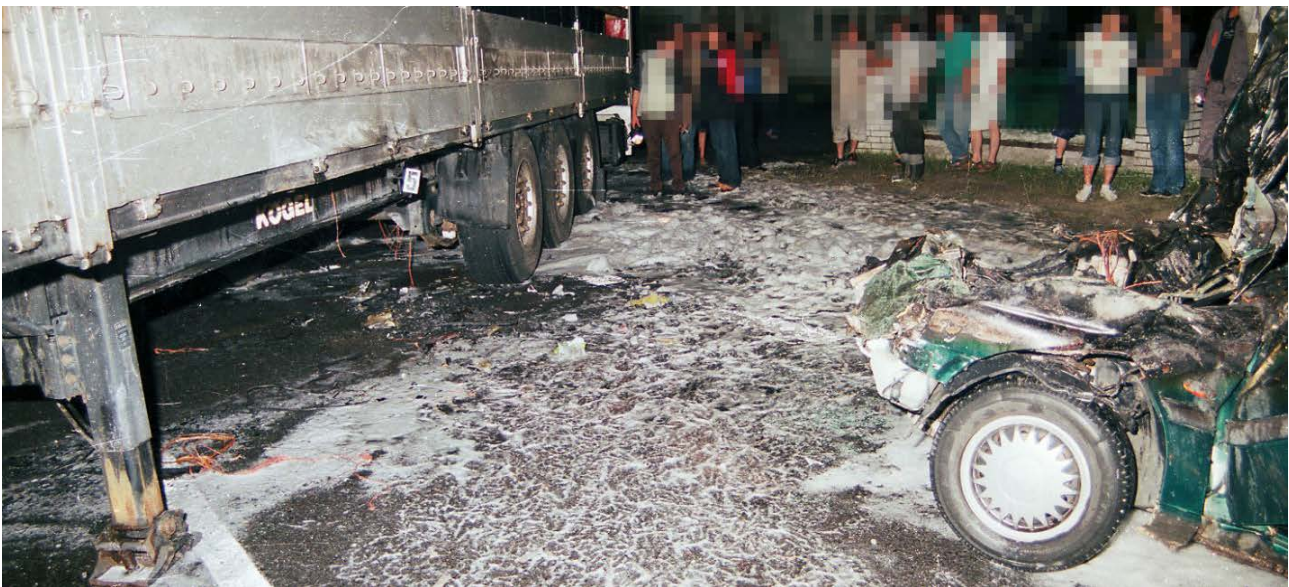
On both sides of the semitrailer, 2.9 m apart, there were side marker lights amber in colour, with retroreflective elements. On its left side there were scratches and fire-caused scorch marks visible. The truck-tractor was not damaged.

Fig. 3. Damage to the semitrailer and Ford Escort.

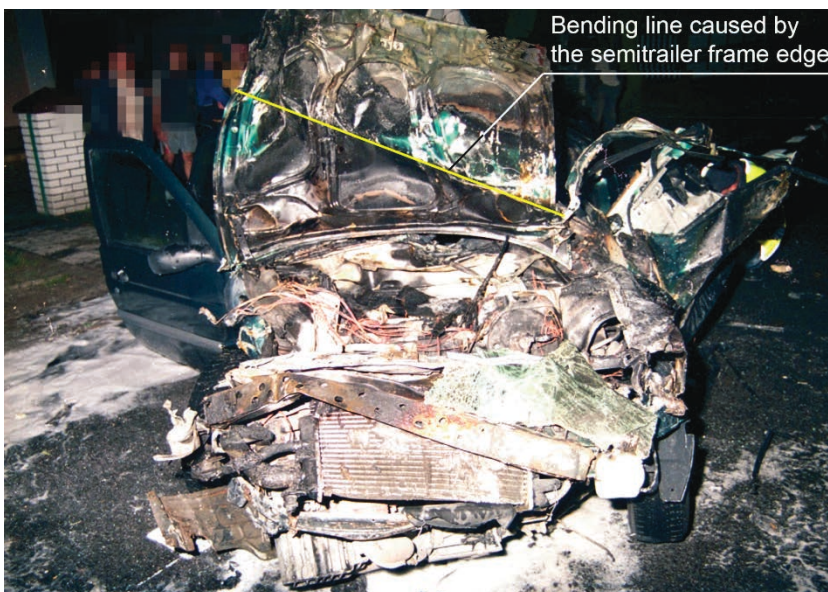
The upright position of the engine cover is evidently not an effect of the collision, but of being lifted by the firemen to reach and extinguish the fire source, after the car was pulled away from the semitrailer. The creases in the whole area of the cover, however, resulted from its being pushed down during the underride.

Fig. 4. The edge of deformation of the engine cover caused by the semitrailer frame edge.

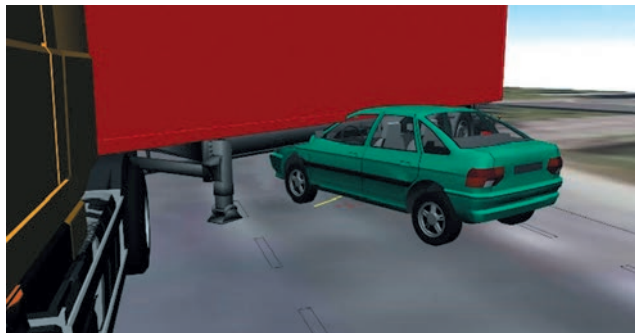
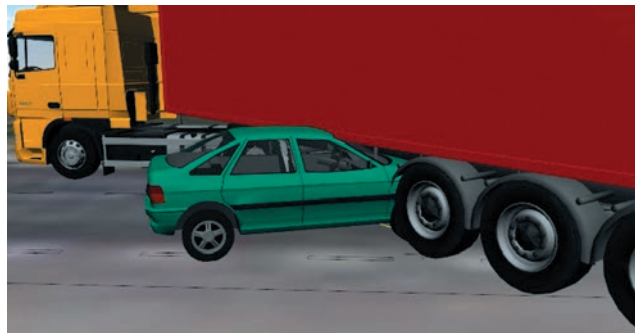
The cover of the car engine compartment, shifting under the semitrailer's frame, was pushed downward and deformed from above. At the same time, the car rotated counter-clockwise through a shallow angle. The Ford's underride was stopped when its front left pillar reached the edge of the cargo box. In Figure 4 the yellow line indicates the rectilinear edge of the deformation, which passes diagonally through the engine cover, which undoubtedly is a representation of the bottom edge of the semitrailer frame, and so indicates the final position of the Ford after it had wedged beneath the semitrailer. The probable end position of the Ford is shown in Figure 5. The complete damage of the car

Fig. 5. The Ford’s position immediately after the collision.

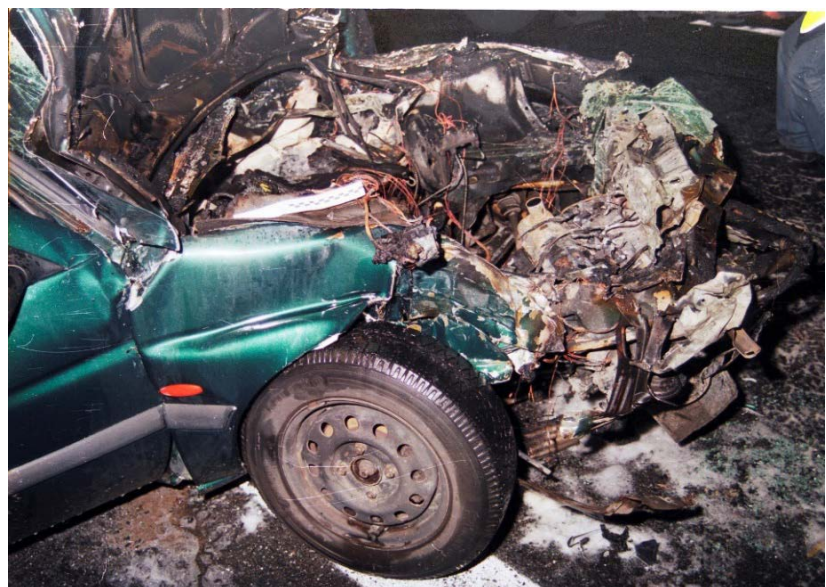
Figure 7 shows the engine compartment whose deformation was divided into two zones and estimated with CRASH3 method (CRASH3, 1986):

- $EES_2 \approx 32 \text{ km/h}$ – characterises the deformation of the area of the right mudguard of the depth of ca. 0.75 m and width of ca. 0.30 m including the backward displacement of the right wheel;
- $EES_3 \approx 25 \text{ km/h}$ – characterises the deformation of the engine compartment from above together with the bending of the door sill with the floor in the area of the front right door. To roughly estimate EES_3 , these deformations were substituted by the longitudinal deformation of the depth of 0.20 m and width of 1.69 m.

Fig. 6. Energy of deformation of the area of pillars and roof (Trego et al., 2003); the values in the fields have the dimension [mph²].

Fig. 7. Deformation of the Ford's engine compartment.

Having adopted the data: $D_1 = (2 \cdot 31 + 4 \cdot 17) / 2 \approx 65 \text{ mph}^2$, $m \approx 1140 \text{ kg}$, $\theta = 50^\circ$ and the values from Figure 6 corresponding to the marked field, $EES_1 \approx 13 \text{ km/h}$.

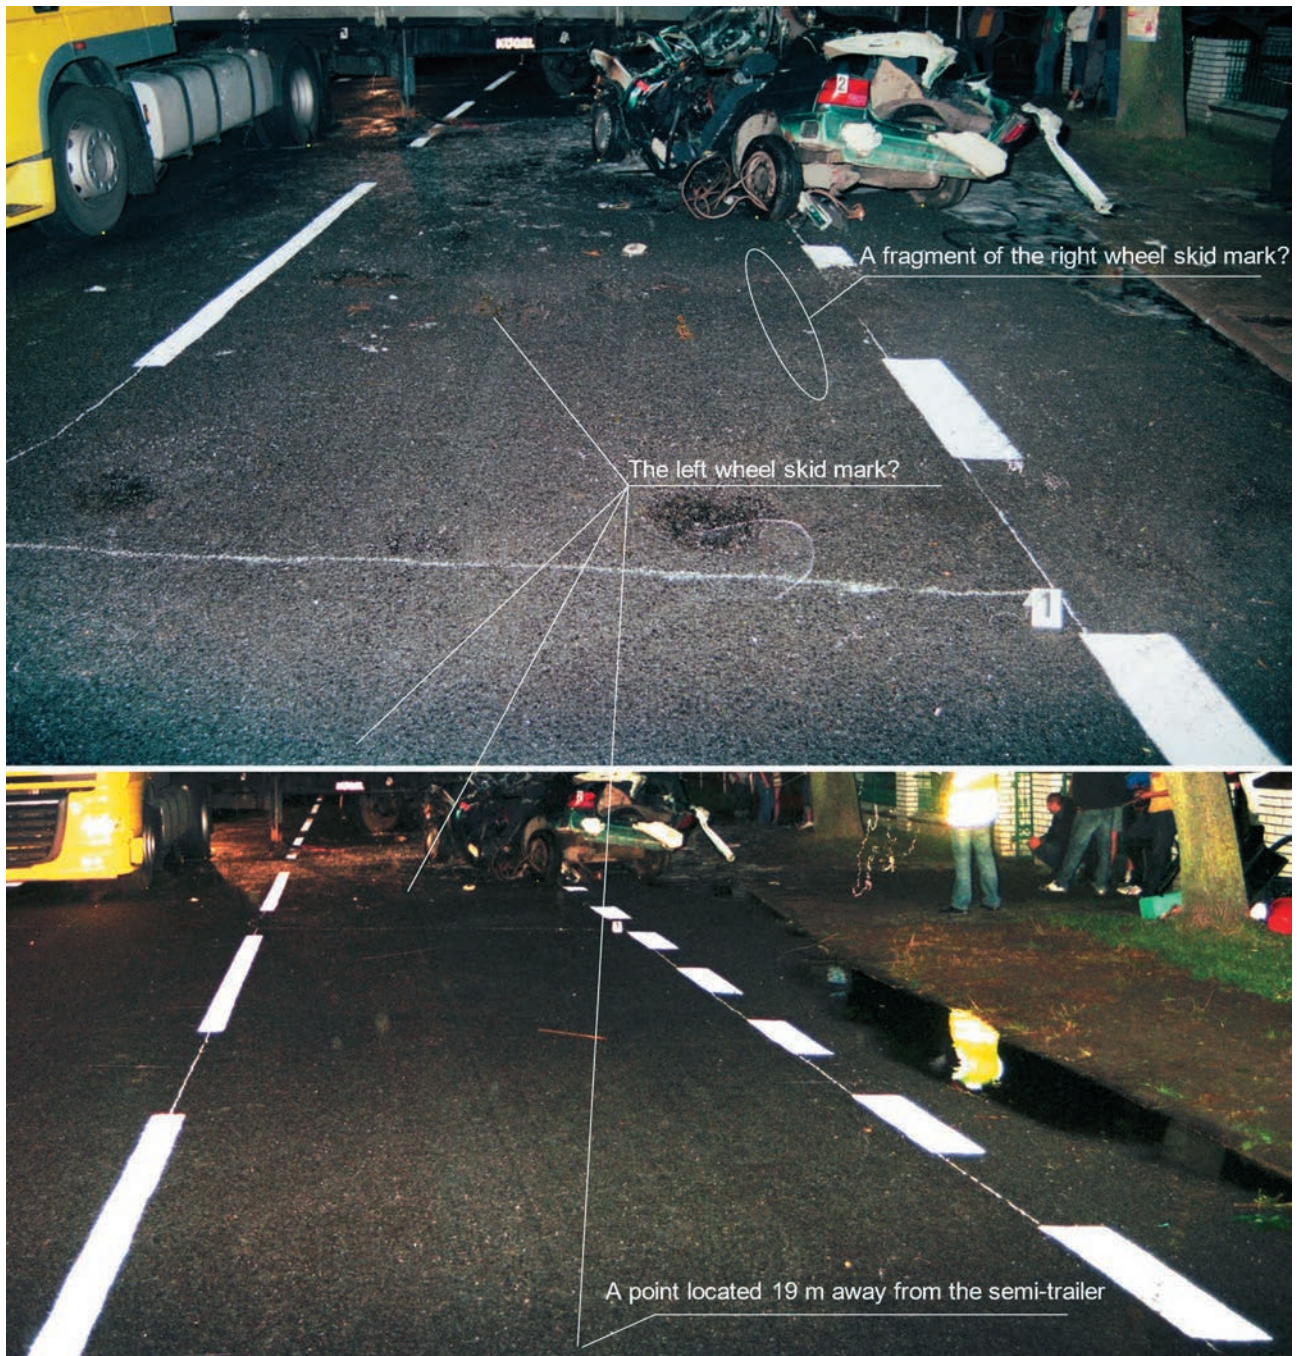
Fig. 10. The rectilinear trace the police failed to disclose.

As can be seen in Figure 10 (and it is even better to look at the photograph shown in it on the computer screen), on the right lane of the road in front of the Ford there was a long straight trace that looked like a track of a wheel braked violently. From its localisation across the road it may be inferred that it might have been left by the Ford's left front tyre, and although on the subsequent section it is covered with foam, its extension leads straight to the Ford's impact position. It is highly unlikely that the track was made during the rescue operation, because on the entire length it is straight, with no curves, and had been made before it was covered with foam. This hypothesis is also supported by the findings of the inspection of the scene of accident. Because of the limited scope of the paper, the details of this reasoning have been omitted.

The track continues beyond the bottom photograph in Figure 10. Hence it is known that it was at least 19 m long, however, its entire length cannot be specified because the photographs in the records of investigation, showing the anterior section of the road, are poorly exposed. By means of *PC-Rect* program a photogrammetric transformation of the photographs in Figure 10 was performed, which produced an orthophotomap shown in Figure 11. The solid lines indicate the path of the left track, the broken lines – the presumed right track.

If it were concluded that the track visible in the photographs was left during the accident, it would mean that the Ford's speed prior to sudden braking was at least 71–76 km/h. After the data:

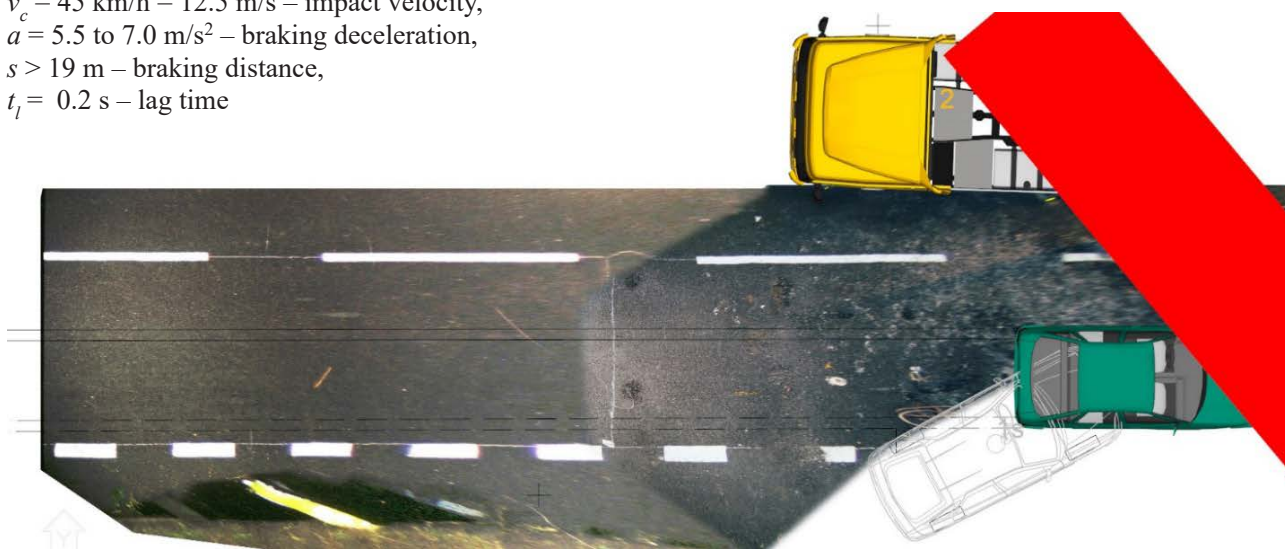
Fig. 11. Orthophotomap of the accident scene.

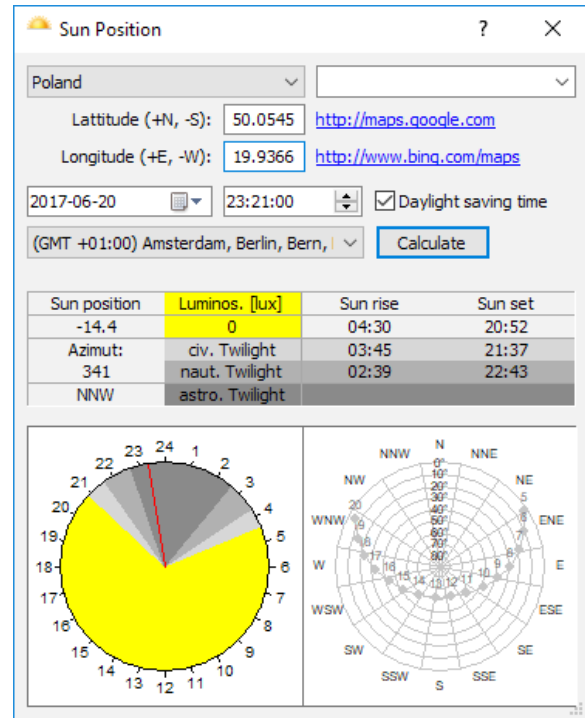
The experiment was performed on 20 June 2017, it started at 11:20 p.m. This time was selected to ensure identical natural illuminance (0 lx, Figure 12b), prevailing at the time of the accident at about 10:10 p.m., on 13 May 2011 (0 lx, Figure 12a).

Fig. 12. Selection of the time of experiment on account of illuminance: a) illuminance at the time of accident at around 10:10 p.m., 13 May 2011, b) illuminance during the experiment that started at 11:20 p.m., 20 June 2017.

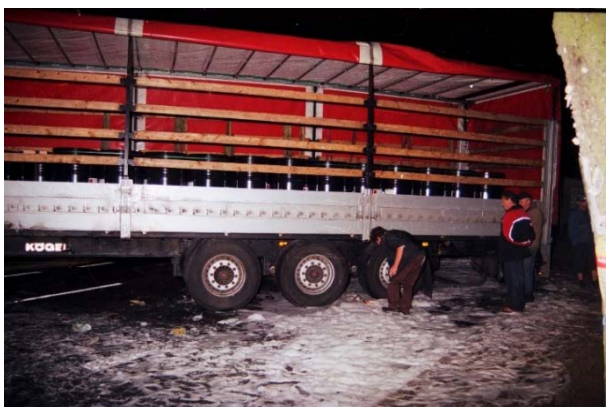
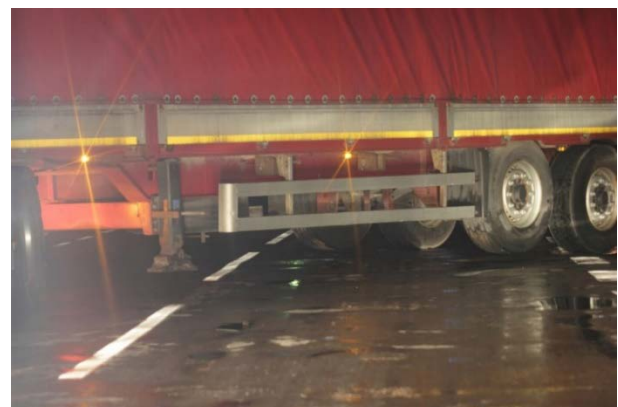
In the experiment two vehicles were used: a Ford Escort car with headlamps similar to those of the car involved in the accident, and a truck-tractor with a semitrailer shown in Figure 13.

The differences visible in the photographs were easily removed, taking the elementary measurements on the identical elements, on different elements for comparison only.

Fig. 13. Comparison of the semitrailers: a) the semitrailer involved in the accident (photograph taken with a flash-lamp), b) the semitrailer used in the experiment (no flash-lamp).

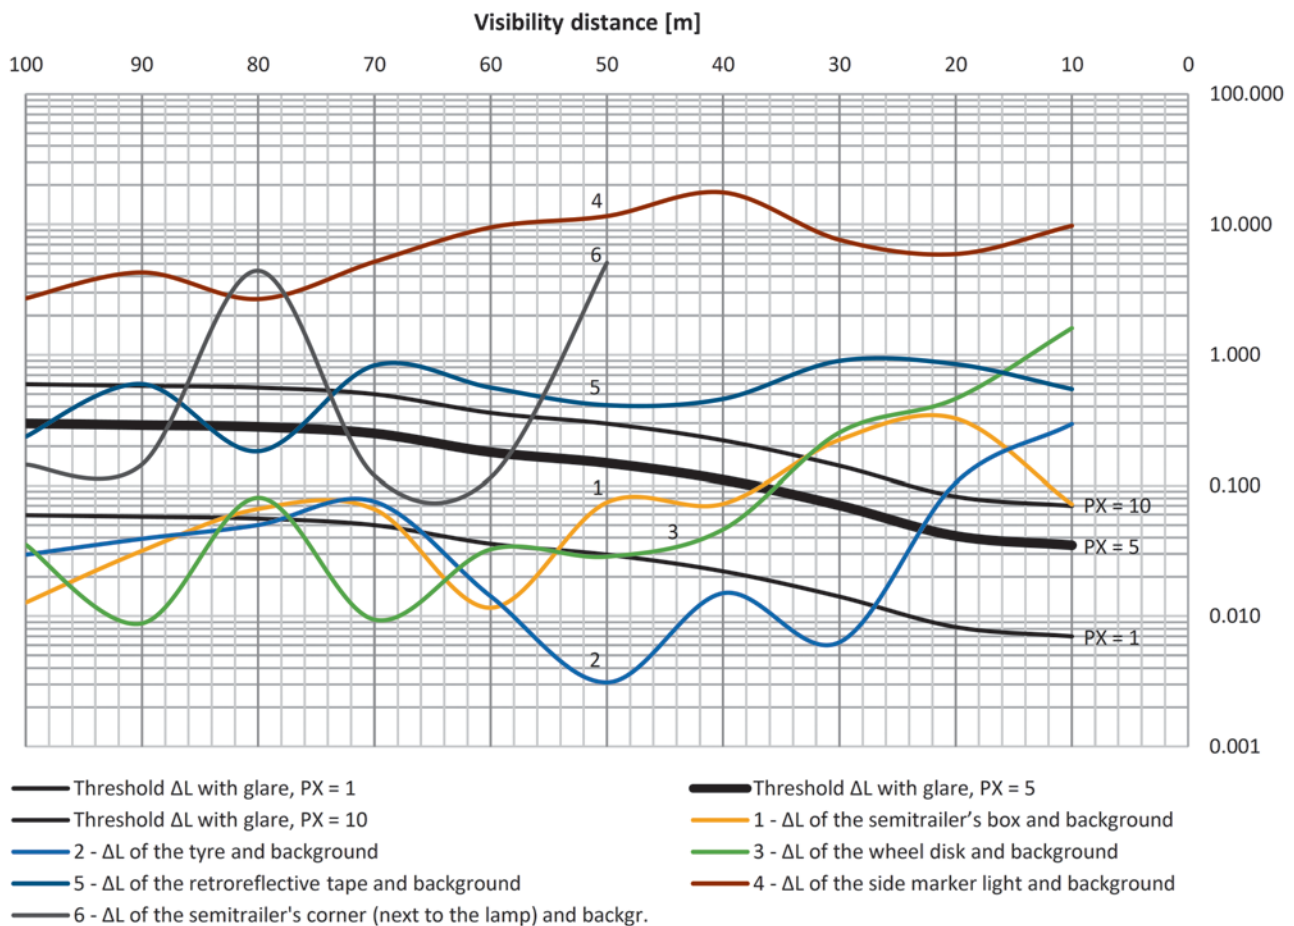
The following observations should be made about the results of the calculations presented in Figure 15:

- the thick black curve B (for $PX = 5$) is the threshold line, the lines above this curve indicate a high probability of recognition;
- the side marker lights of the semitrailer (line 4) were visible over the entire driving time, that is from the distance of 100 m away from the semitrailer;
- the semitrailer's side (line 1) and the rim of the front left wheel (line 3) should have been sighted from the distance of 36–37 m;
- the semitrailer's front left tyre (line 2) should have been sighted from the distance of 22–24 m;
- by way of comparison – the retroreflective tape on the vehicle's side (line 5) could have been sighted from the distance of ca. 74 metres, but, obviously, there was no such tape on the semitrailer involved in the accident;

- in the case of the illumination of the area by a road-side lamp, the line of sighting the front upper corner of the semitrailer or the upper part of the cab (line 6) indicates that this region could have been sighted briefly when the Ford was between 85 and 75 metre ahead of the obstacle, and then again at distances of less than 56 m. The problem is that the driver knew there was a truck sitting there and this position did not signify an imminent hazard. Moreover, it was not in the field of concentration and visual acuity, whose cone was relatively narrow (opening angle 2°). Therefore, the lack of the possibility of sighting this element of the vehicle cannot be regarded as an indicator of the hazard caused by the crosswise position of the remaining part of the semitrailer.

Fig. 15. Results of calculations of sighting distance of semitrailer's various elements.

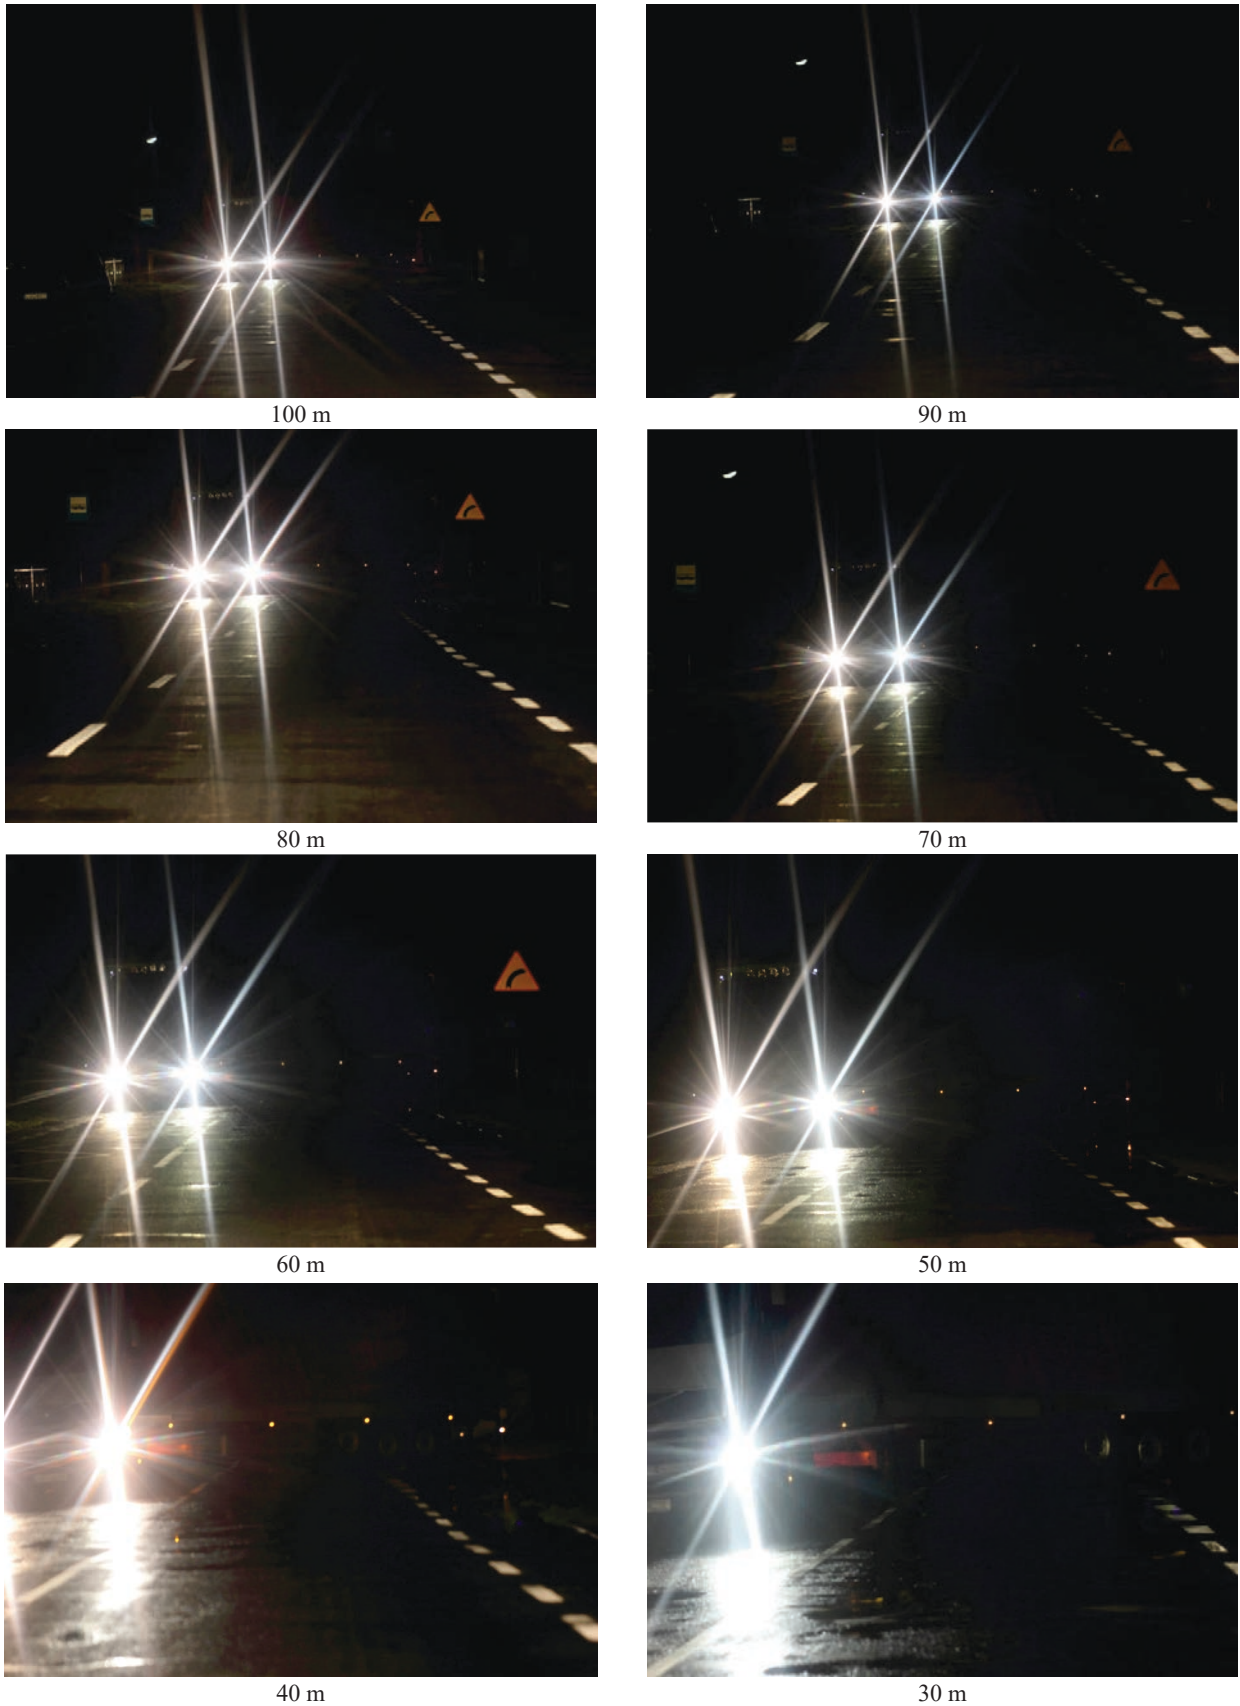
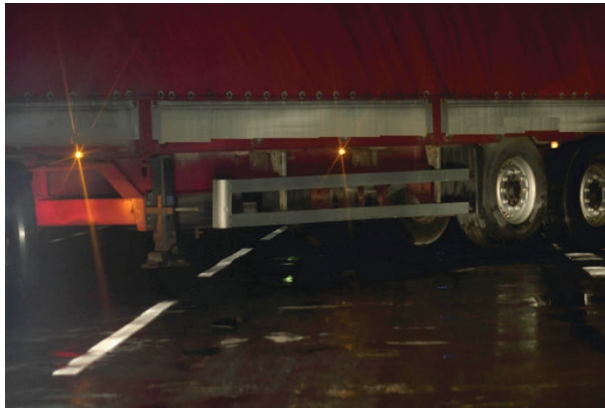
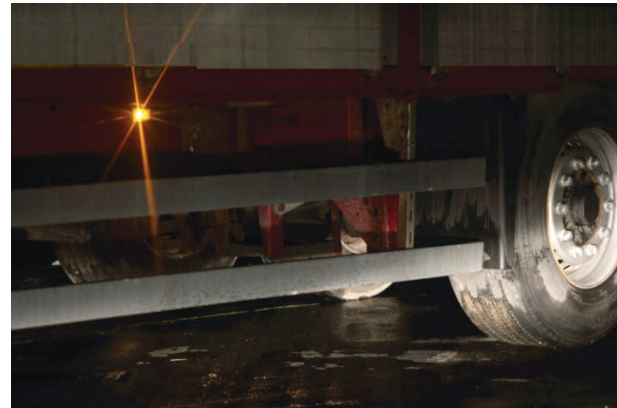
Figure 16 shows a series of photographs taken every 10 m, starting from the distance of 100 m and ending at 10 m away from the semitrailer. In the photographs the retroreflective tape was removed and one amber side marker light was added.

Fig. 16. Stopped combination vehicle from subsequent distances from 100 m to 10 m from the semitrailer, every 10 m.

Fig. 16 (continuation). Stopped combination vehicle from subsequent distances from 100 m to 10 m from the semitrailer, every 10 m.

are visible all the time because they are bright but difficult to identify on account of their very small size. The wheel disk and the side of the semitrailer should have been seen from the distance slightly less than 40 m, while in the photograph taken from the distance of 50 m they are not conspicuous yet. The tyre, on the other hand, becomes conspicuous close to the roadway at the distance of twenty-some metres, but in the photograph taken at 30 m it cannot yet be distinguished from the background (wet tyre – damp roadway).

The accident happened at an extremely unfortunate position of the semitrailer relative to the Ford's track, well shown in the photograph taken at the distance of 30 m (Figure 16), and the photograph taken by a police officer (Figure 17) and stored in the case file. On the Ford's movement track extension, where its headlights illuminate the road foreground, there was no part of the semitrailer visible, and the car low beam headlights slid under the semitrailer. As a result, what stood out against the background of the dark roadway

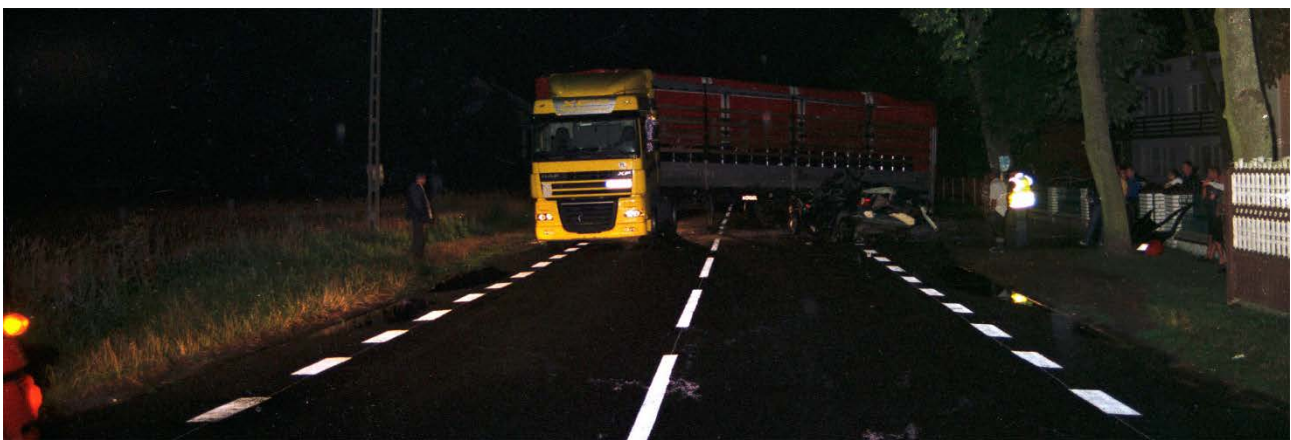
was the white retroreflective central line reaching out beyond the semitrailer, producing the illusion that the road was free on a distance longer than that from the semitrailer, not yet visible. It is a known phenomenon in similar configuration of vehicles, when it turns out that the obstacle blended in with the background is closer than suggested by the illuminated section of the road.

Fig. 17. A photograph in the records of investigation: the centre broken line on a road section longer than the distance from the semitrailer.
